## Test Report

No.SDHL250901687101HI-1

Sample Description : TIMBEX DECK

1.Test Item: Falling mass impact resistance

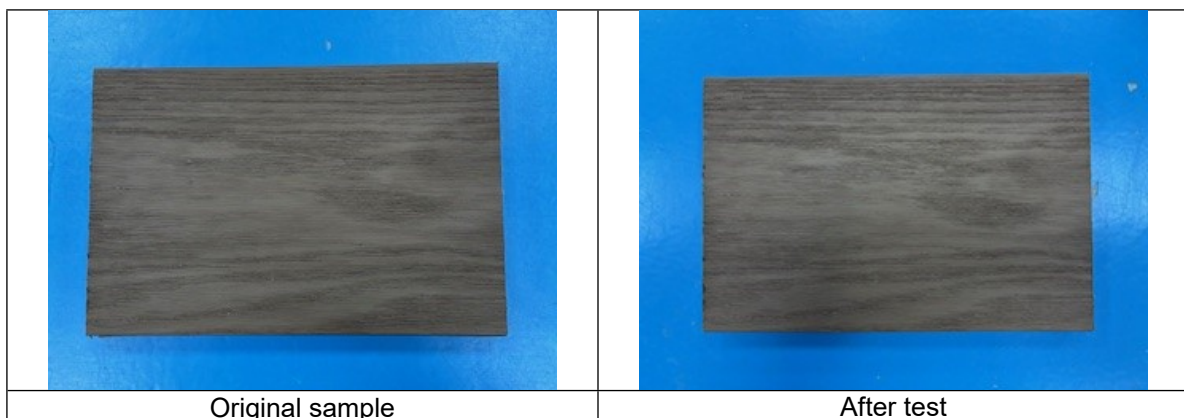
### Photo Appendix:

Sample Description: See photo

Test method: EN 15534-1:2014+A1:2017 (E) Clause 7.1.2.1 & EN 477:2018 (E)

Diameter of steel ball: (25±0.5)mm

Weight of steel ball: (1000±5.0)g

Drop height: 700mm

Support distance: (200±1.0)mm

| Test result | Conclusion |
|---|---|
| No visible cracks | / |
